Manhole Inspection Summary

Manhole # S35SS_021MH

Insp Date: **1/12/07 12:23 PM**

Location Address: **2613 BARCLAY ST**

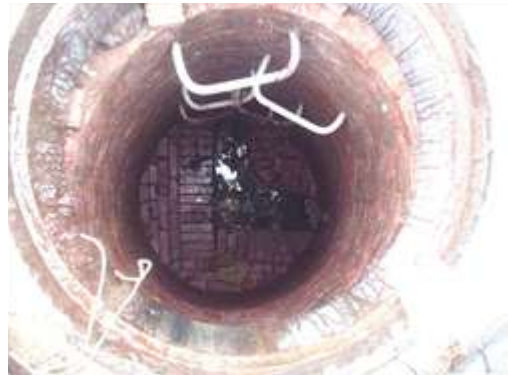
Top View

Corroded steps. Bench and Channel debris.

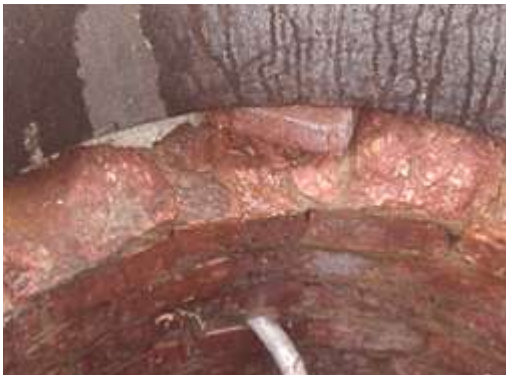
Defect

Frame Offset: **3** (in.) Condition: ☒ Sound ☐ Cracked ☐ Leaks

Condition: ☐ Sound ☐ Cracked ☐ Root Intrusion ☒ **Loose Brick** ☒ **Deteriorated**

Infiltration: ☐ None ☒ **Joint** ☐ Cracks ☐ Mortar ☐ Roots ☒ **Wall**

Frame offset. Adjustment deterioration, loose brick and infiltration.

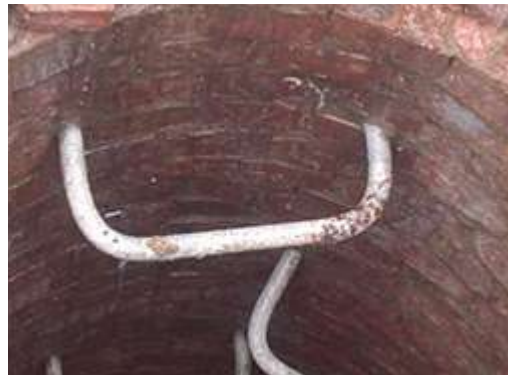
Defect

Adjustment deterioration and infiltration.

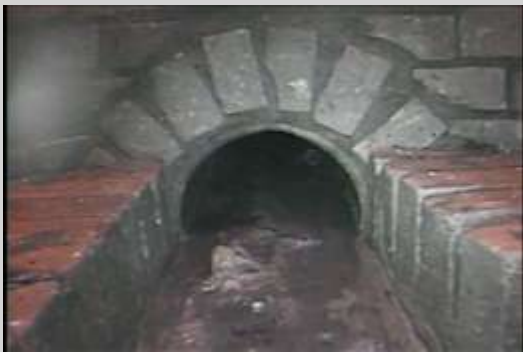
8 in. Circular Gravity Sewer Pipe Out @ 12 O'Clock

Deposits: ☐ None ☒ **Mud** ☐ Sludge ☒ **Debris** ☐ Grease

Silt Depth: **2** (in.) Deposits Extent: **Light**

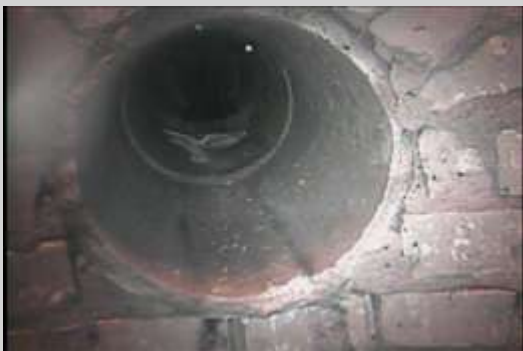
8 in. Circular Gravity Sewer Pipe In @ 3 O'Clock

Deposits: ☐ None ☒ **Mud** ☐ Sludge ☒ **Debris** ☒ **Grease**

Silt Depth: **6** (in.) Deposits Extent: **Heavy**

Infiltration: **None** Pipe Seal Cond: **Broken**

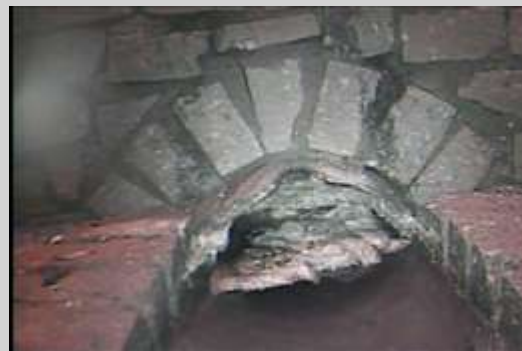
Drop In @ 3 O'Clock

Drop: **Outside** Rod and Bar

Drop Condition: **Open**
